RESERVE STUDY

Park Tower Condominium Association

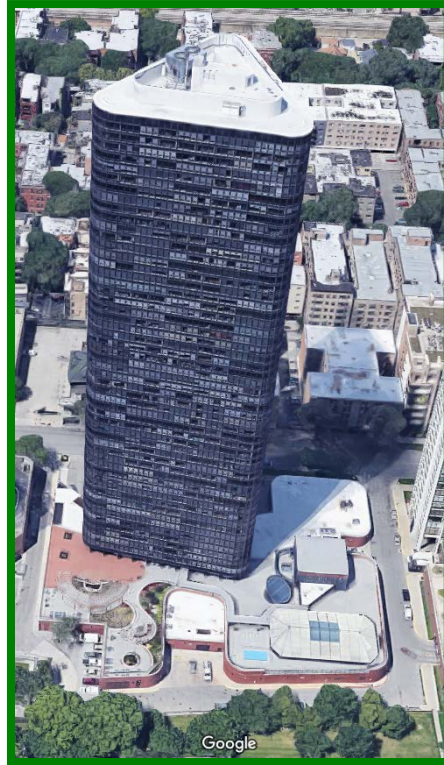
Our investigation includes Reserve Components or property elements as set forth in your Declaration. The Expenditure tables in Section 3 list the elements contained in this study. Our analysis begins by segregating the property elements into several areas of responsibility for repair and replacement.

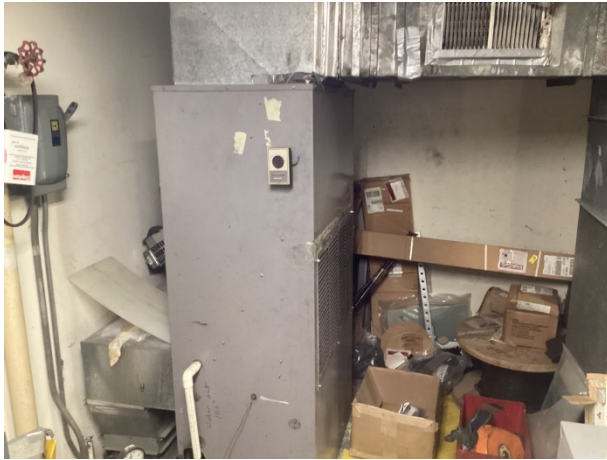
26th floor elevator room air handling unit

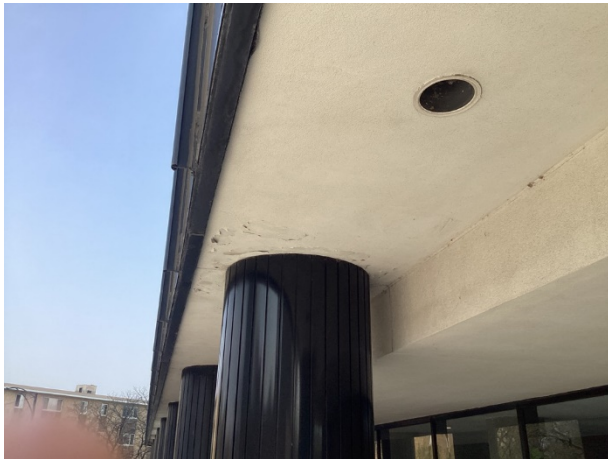
Soffit paint finish deterioration

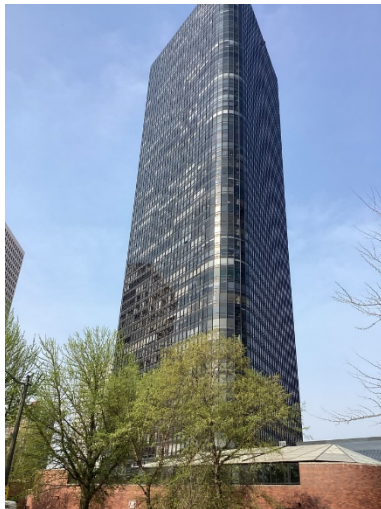
North and east elevations

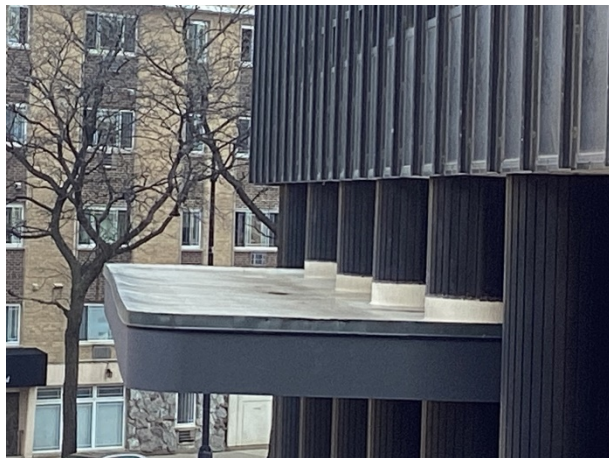
- **Tower, Main and Mechanical Penthouse** – 10,300 square feet of modified bitumen roofing, replaced 2016, good overall with isolated perimeter sealant deterioration and previous repairs evident
- **Lobby Canopy** – 800 square feet of flat membrane roofing, replaced 2012

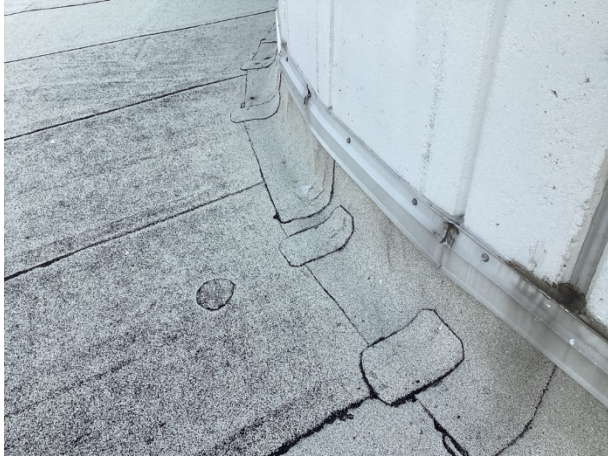
Main roof at perimeter repairs

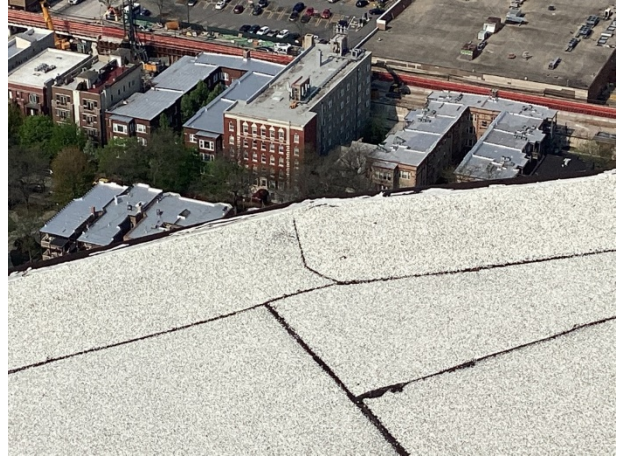
Main roof at perimeter sealant

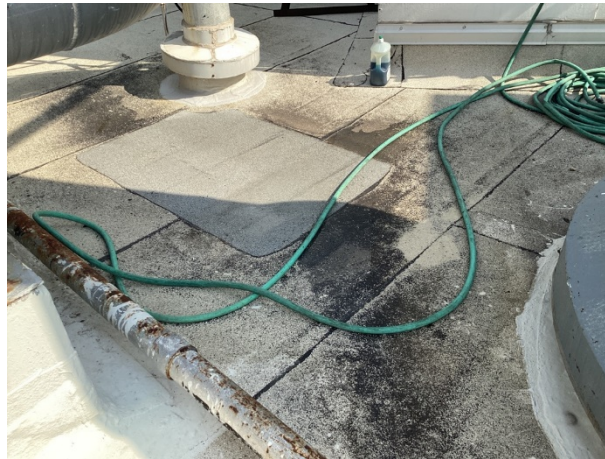
Main roof at repairs and lack of drainage

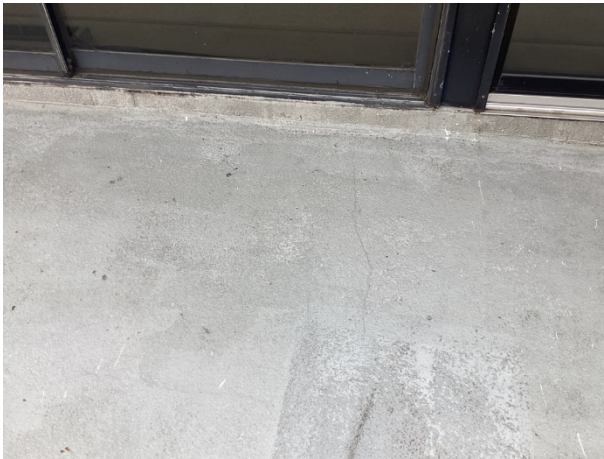
Crack at 2nd floor coating

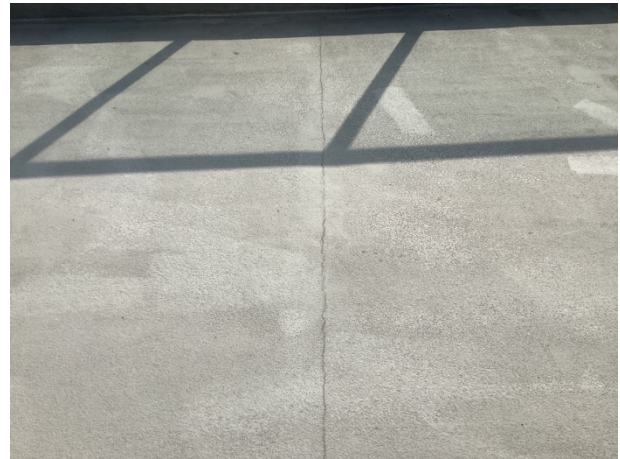
Crack at coating at 2nd floor

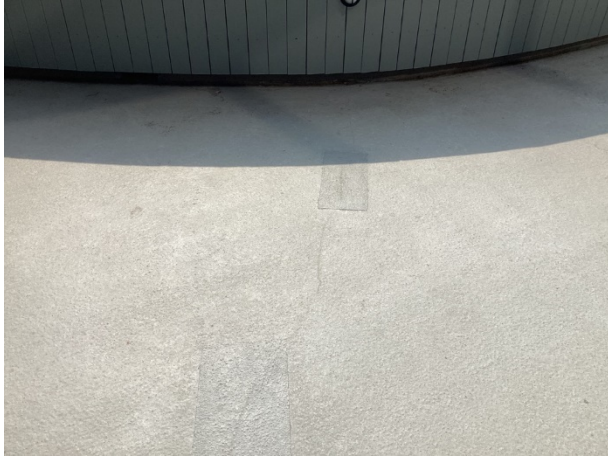
Cracks at 2nd floor coating

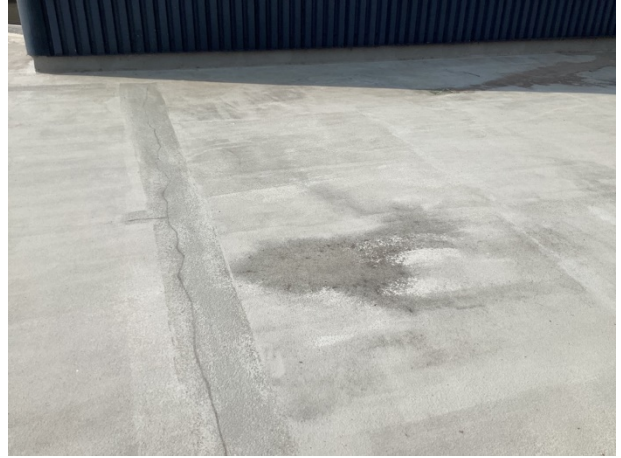
Lack of drainage at 2nd floor roof

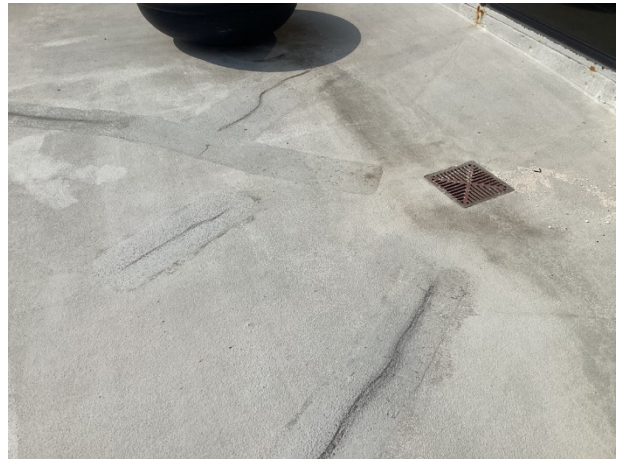
Repaired cracks at 2nd floor roof

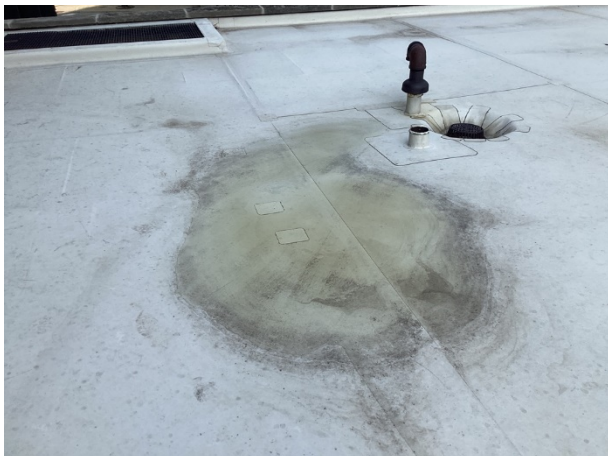
Northwest roof at 2nd floor at lack of drainage

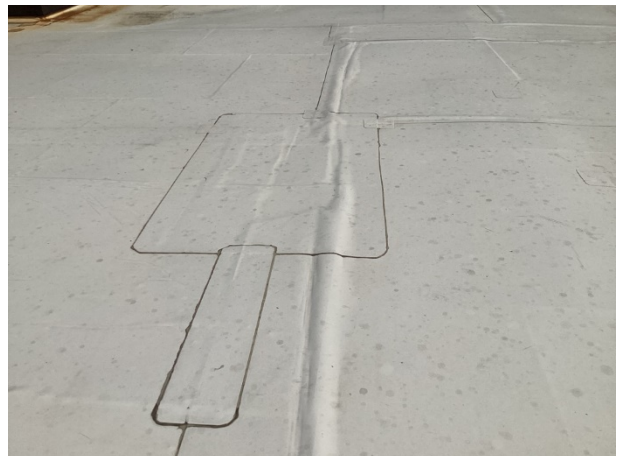
Northwest roof repairs at 2nd floor

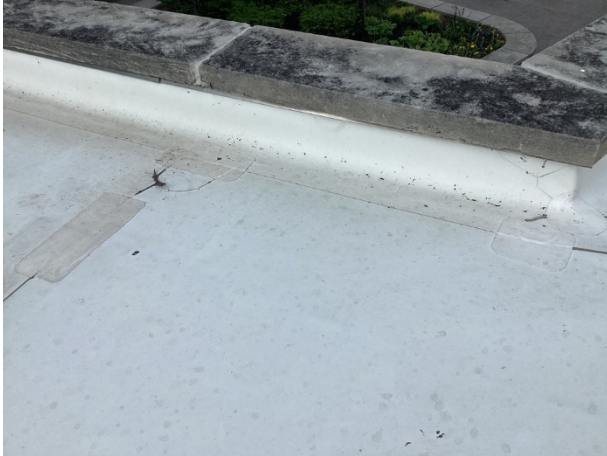
Perimeter at 2nd floor northwest roof

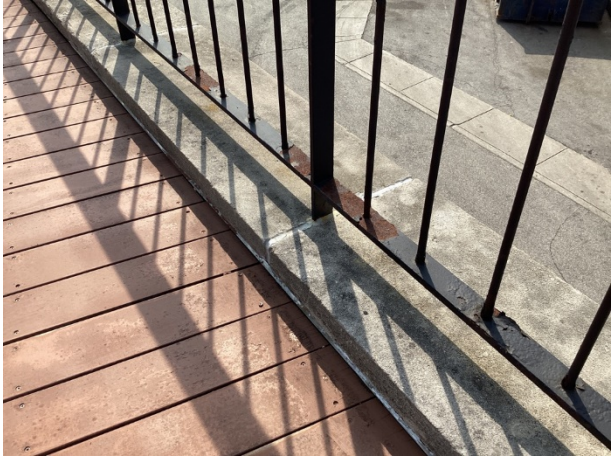
Corrosion at railing

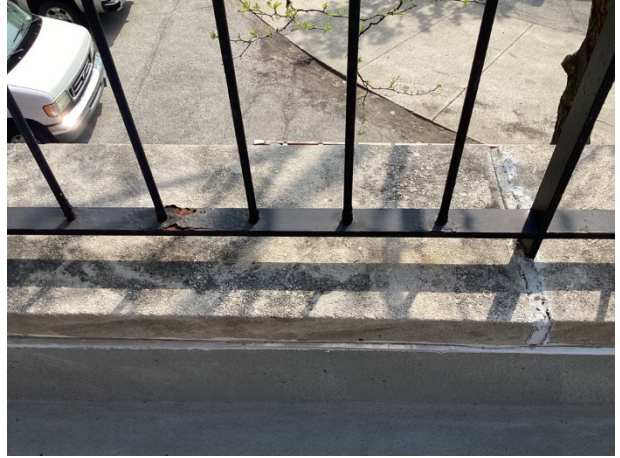
Corrosion at railing

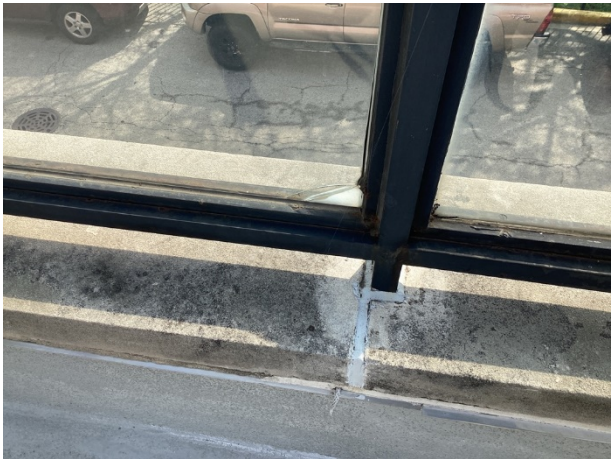
Frame corrosion and glass damage

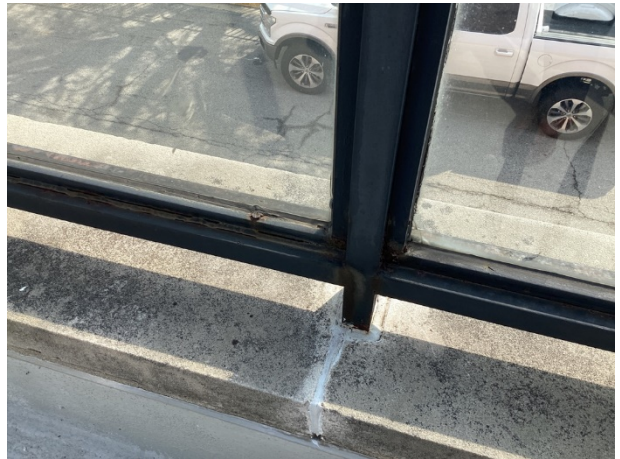
Frame corrosion and glass damage

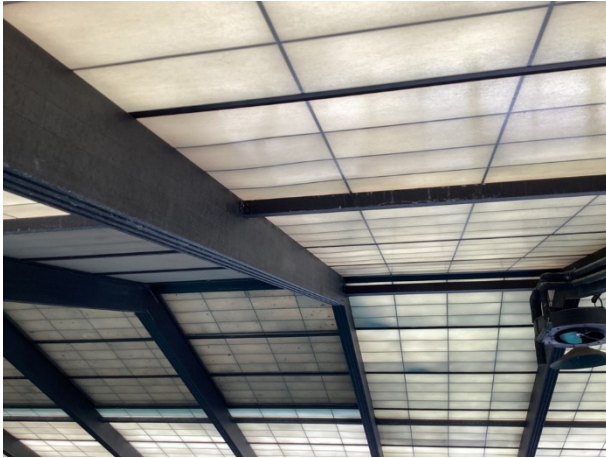
Quantity, History and Condition: The pool enclosure was installed in 1997 and includes approximately 4,700 square feet of *Kalwall* translucent panels with a steel structure. The pool structure exhibits evidence of water infiltration. We include the remaining cost to replace the roof system in the near term as provided by Management.

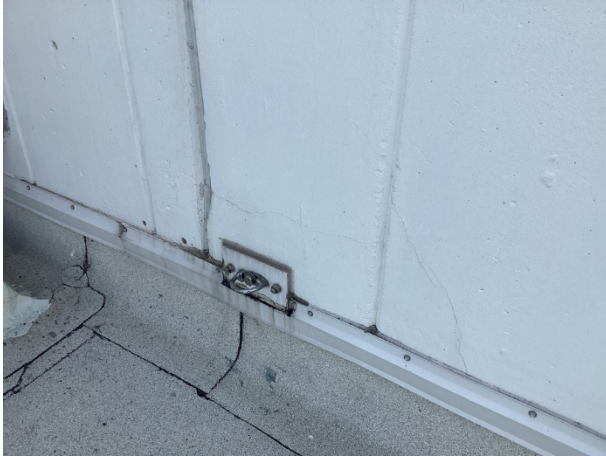
Concrete cracks at penthouse

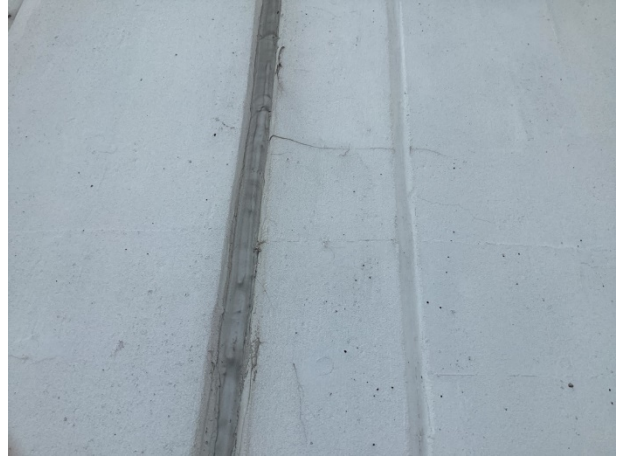
Concrete cracks at penthouse

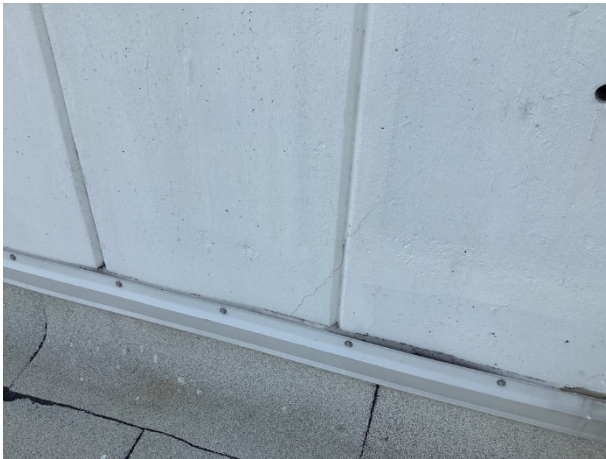
Concrete cracks at penthouse

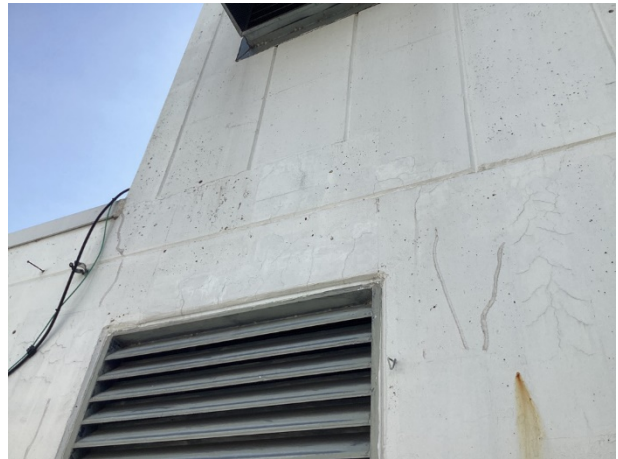
Repaired cracks at penthouse

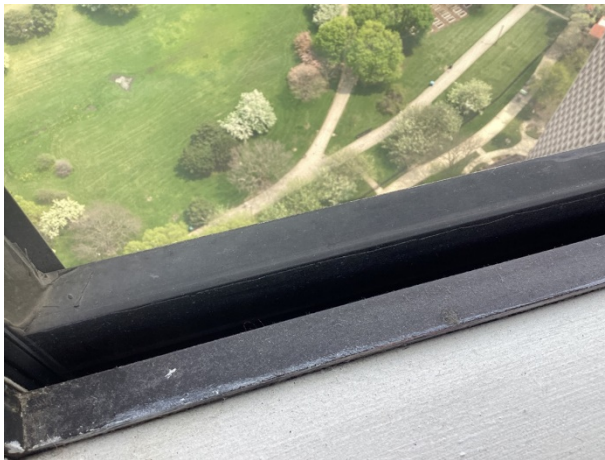
Deterioration of weather strip at operable window

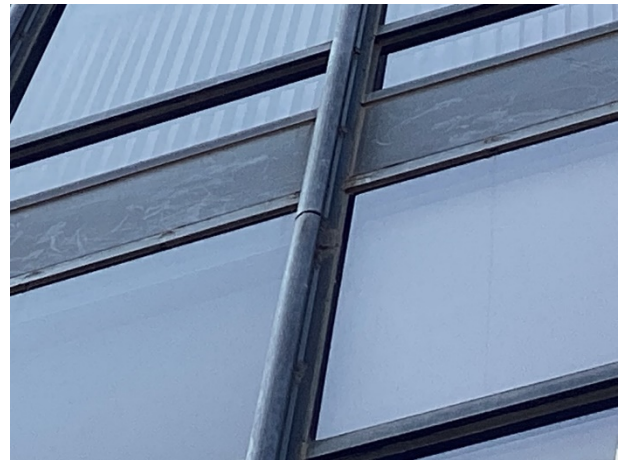
Glass to metal sealants

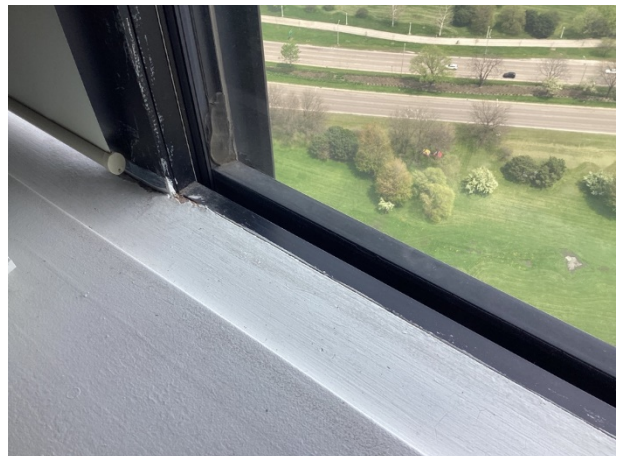
Weather strip deterioration

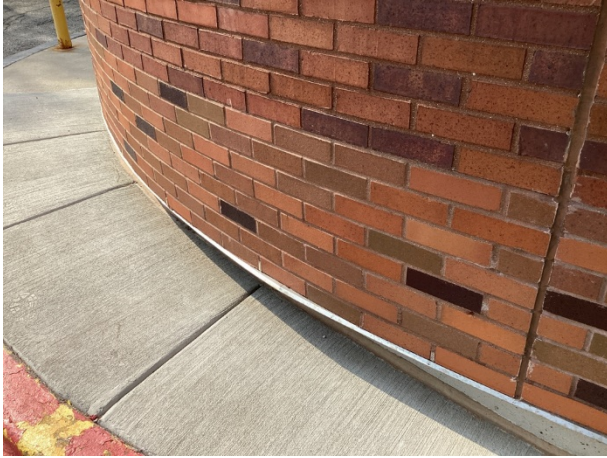
Base flashing installed

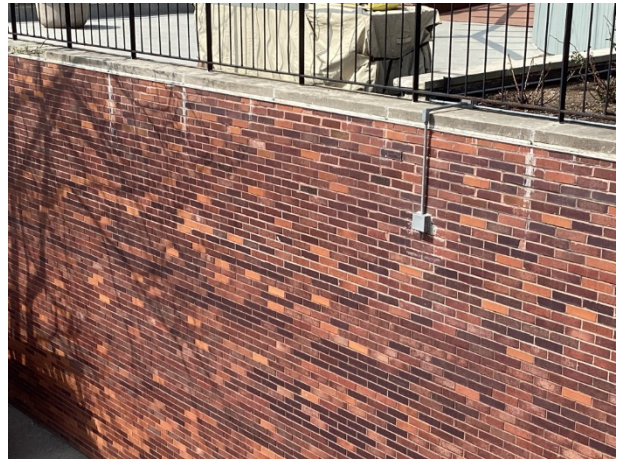
Overall deterioration of masonry wall

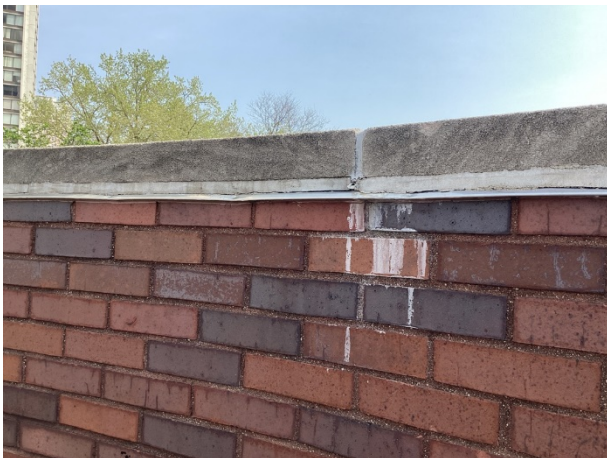
Sealant deterioration at cap

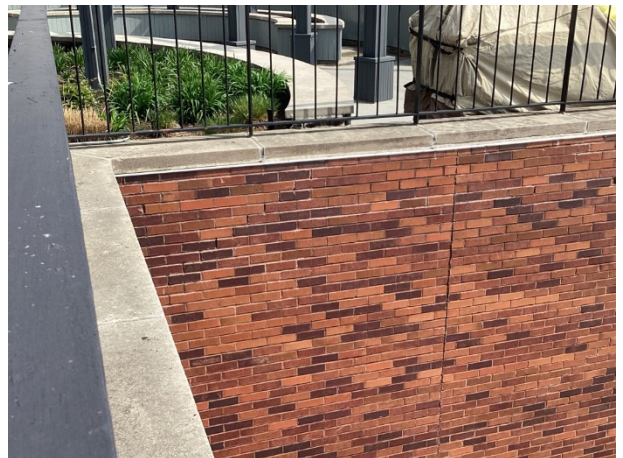
Spall and cracks at masonry wall

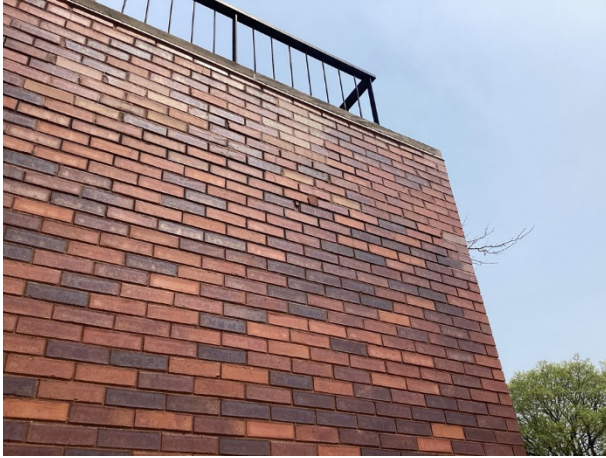
Spall and joint deterioration at masonry

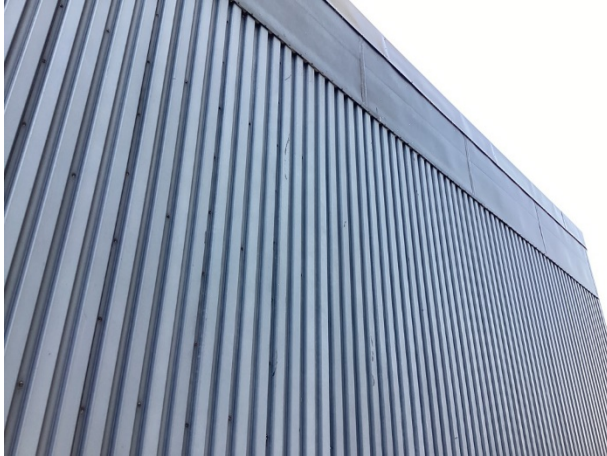
Quantity, History and Condition: The exterior elevations of the racquetball courts and mall atrium include approximately 5,000 square feet of prefinished metal siding. The siding is in fair overall condition. Areas of finish damage/deterioration are evident. Corrosion is evident at the base of the panels.

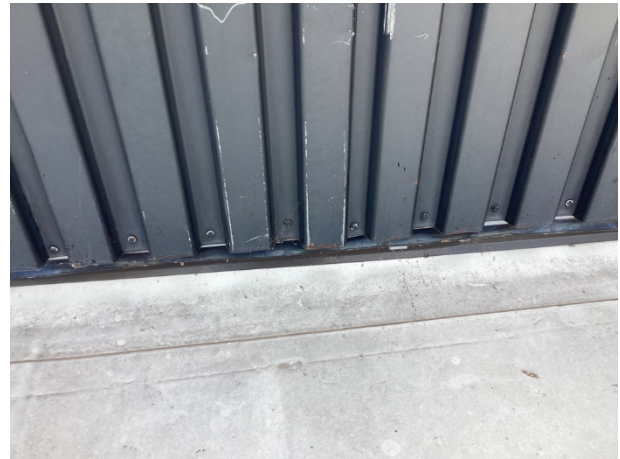
Siding corrosion at base

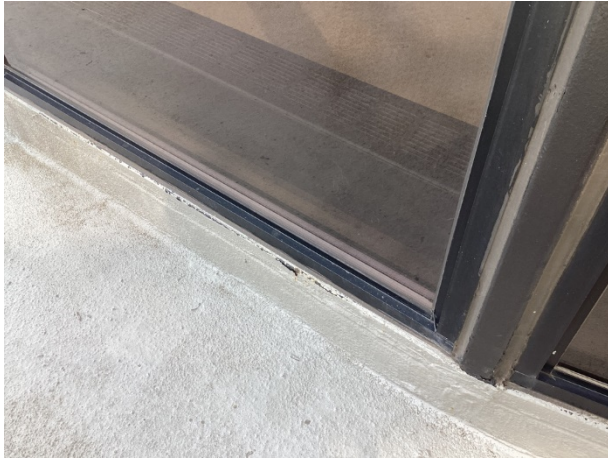
2nd floor walkway window system

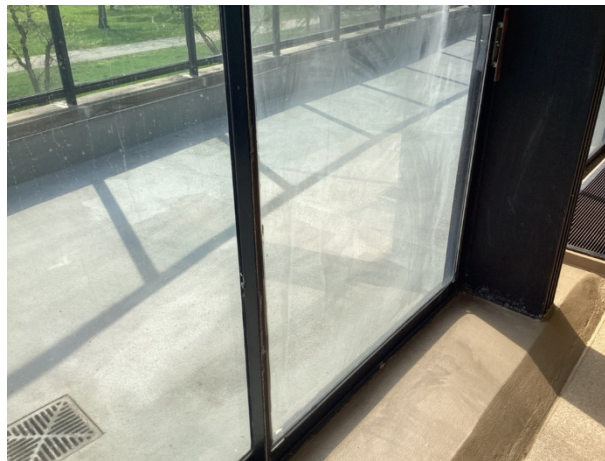
Seal failure at pool sliding door

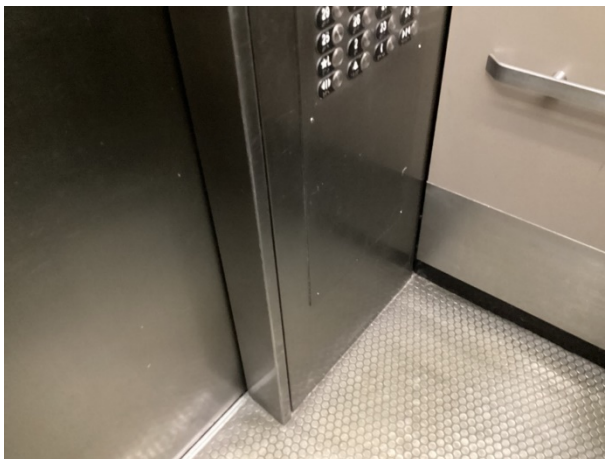
Service elevator cab

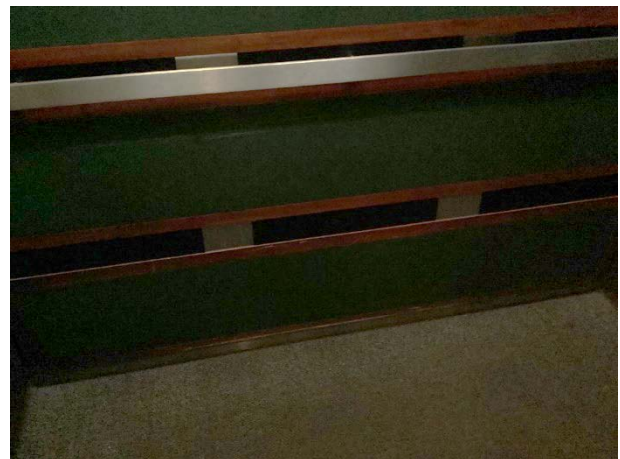
Damage at passenger cab

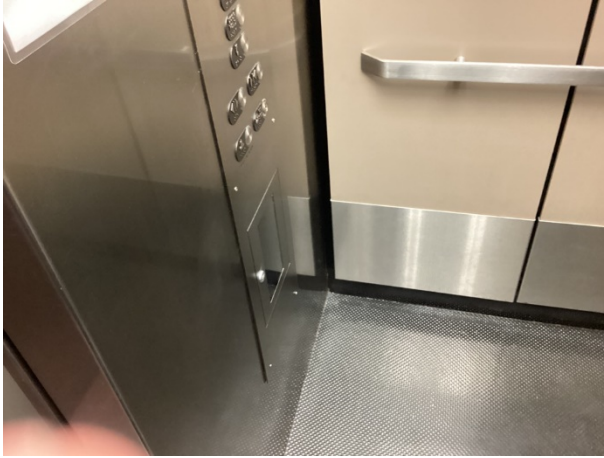
Garage mall elevator cab

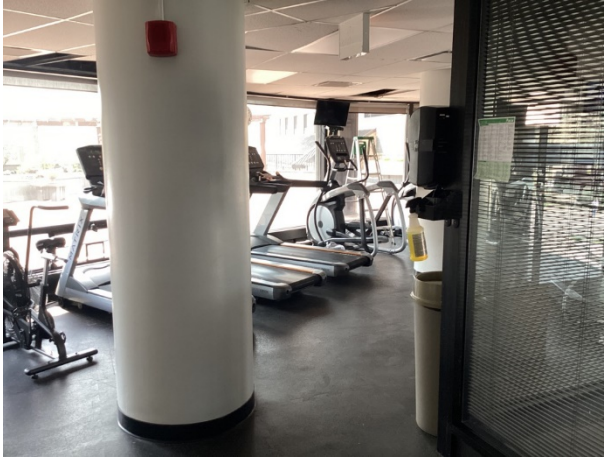
Cardio room equipment

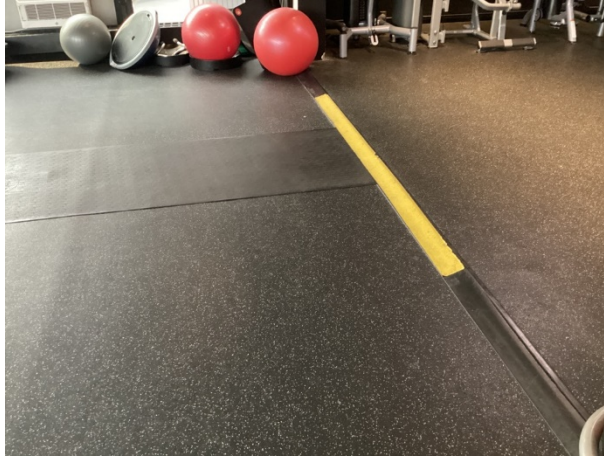
Flooring at exercise room

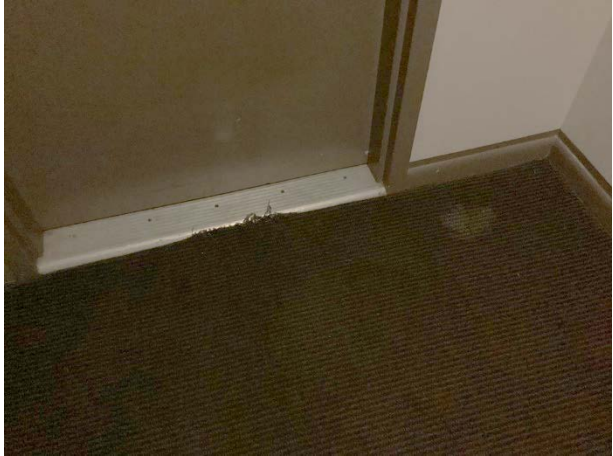
Carpet deterioration at edge

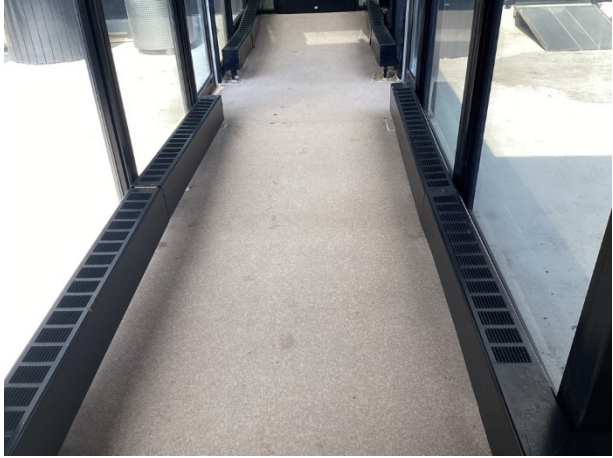
Condition: Fair overall (We include a Management provided cost to replace the vinyl floor coverings with an epoxy floor coating.)

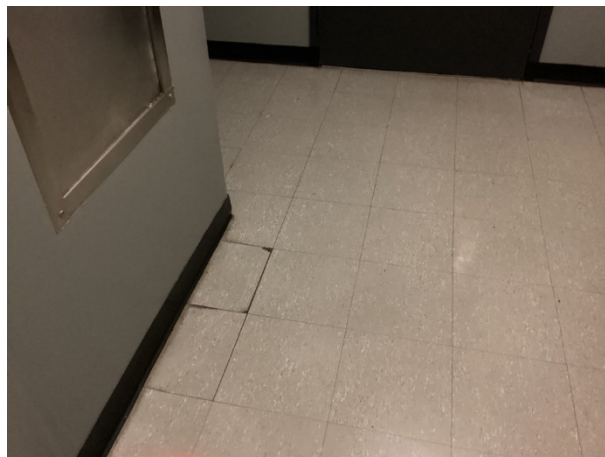
Service foyer floor damage

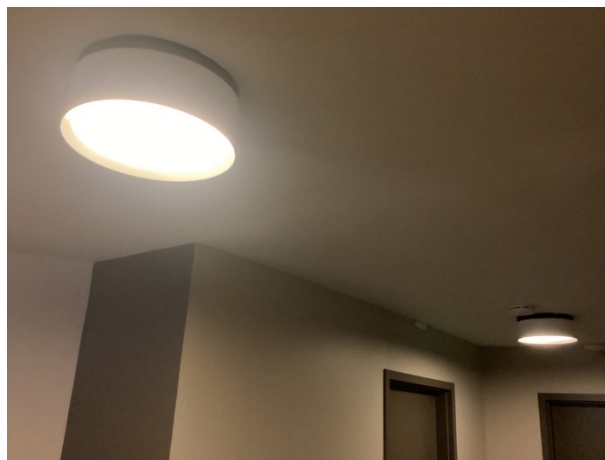
History: Replaced 1988 (We continue to include a Management provided cost for replacement in the near term.)

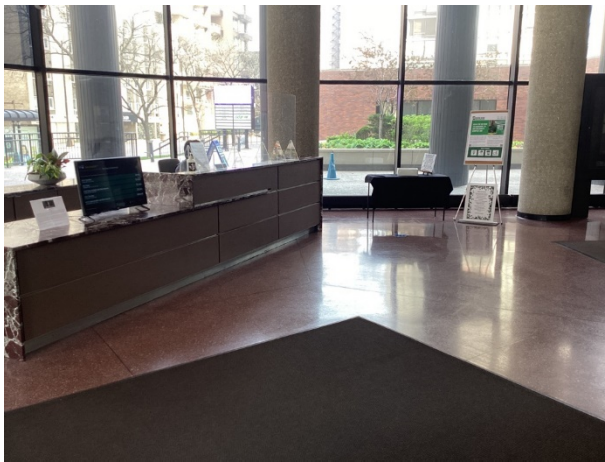
Condition: Reported satisfactory

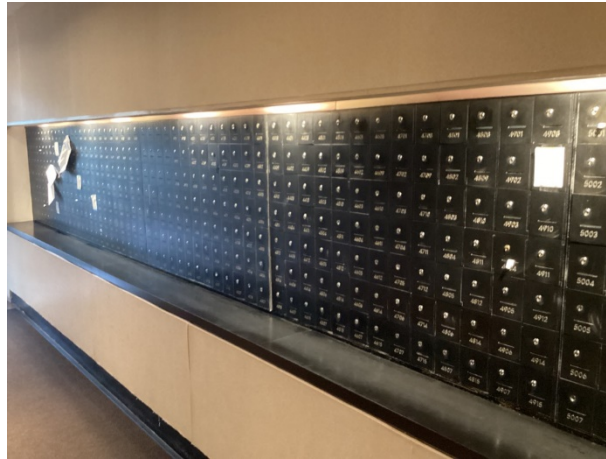
Condition: The mailboxes have limited capacities. The Building Engineer informs us of a limited history of issues.

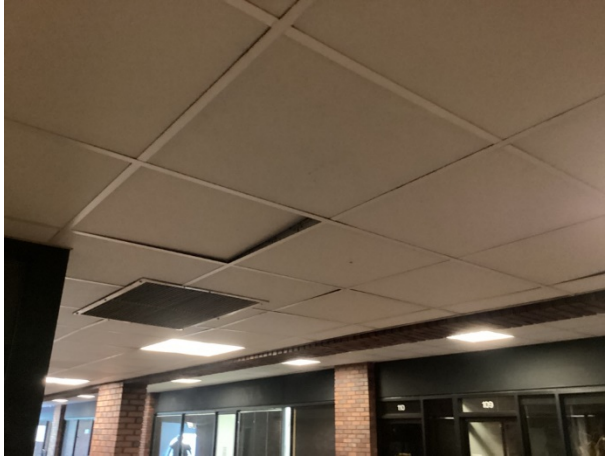
Corridor at mall ceiling tile damage

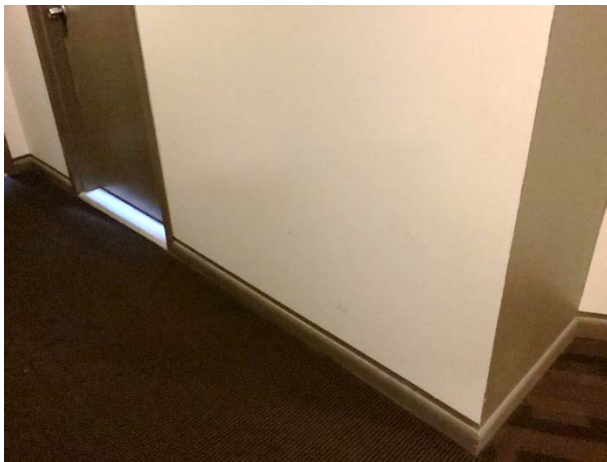
Condition: The paint finishes exhibit a significant amount of scuffs. The wall coverings exhibit areas of damage, stains and separation at seams. We include an expenditure to paint the hallways and replace the wall coverings in the near term as part of the hallway renovation project.

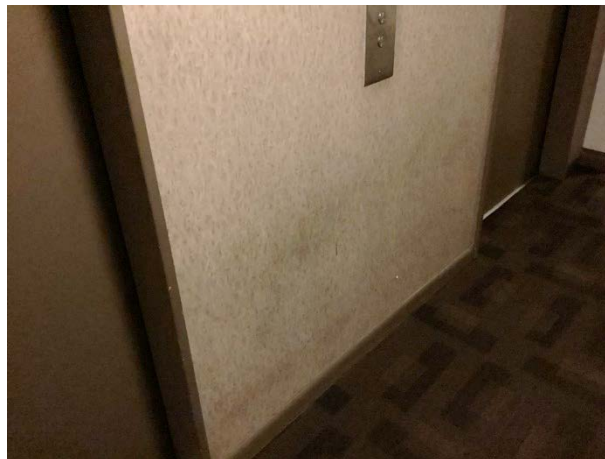
Wall covering damage

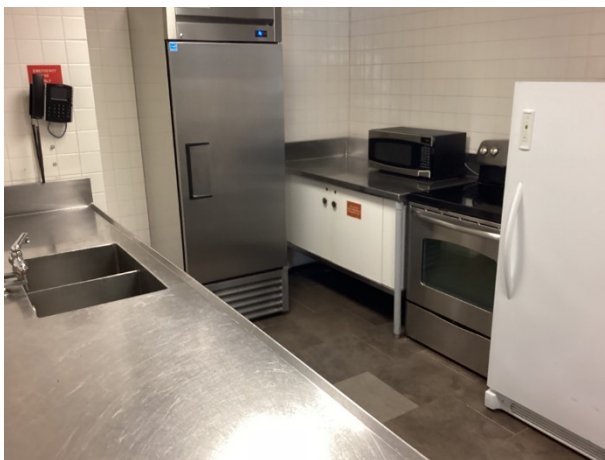
Kitchen at party room

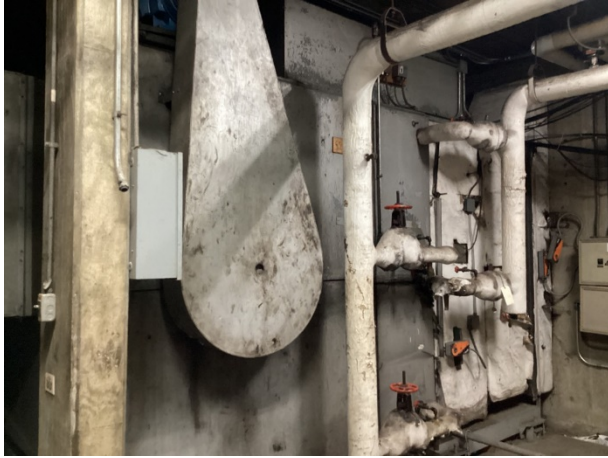
Air handling unit serving hallways

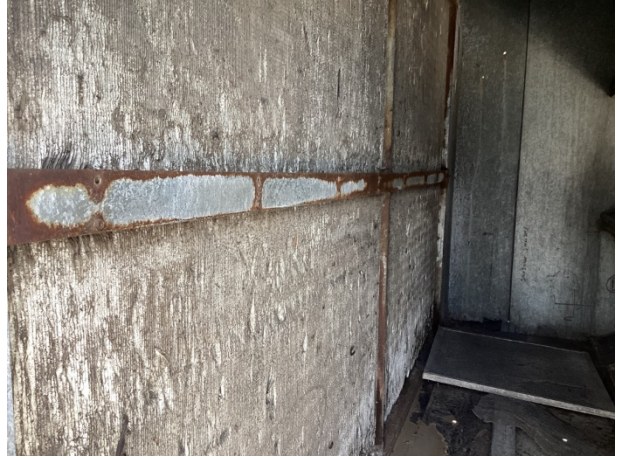
Preheat coil deterioration at hallway unit

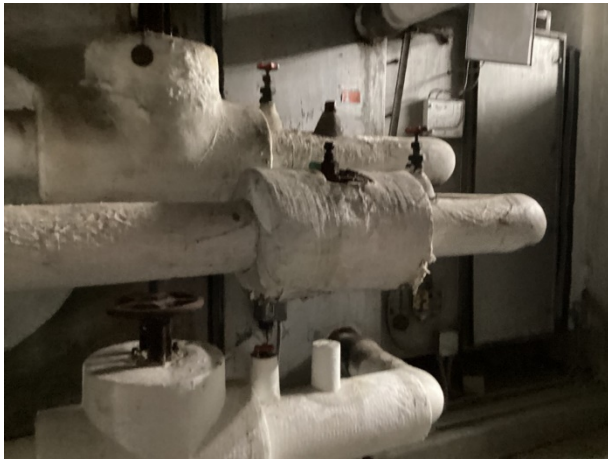
Lobby air handling unit

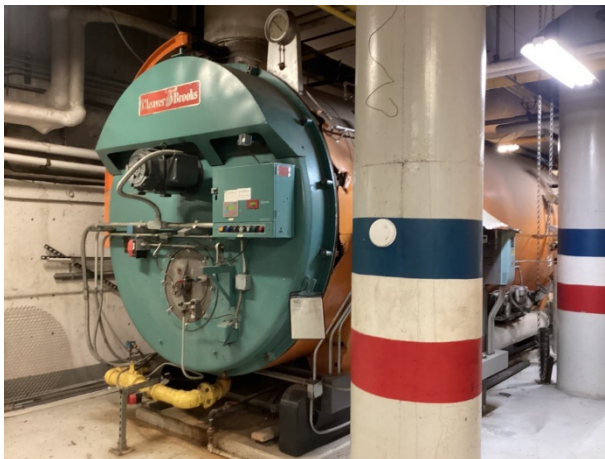
Building heat boiler

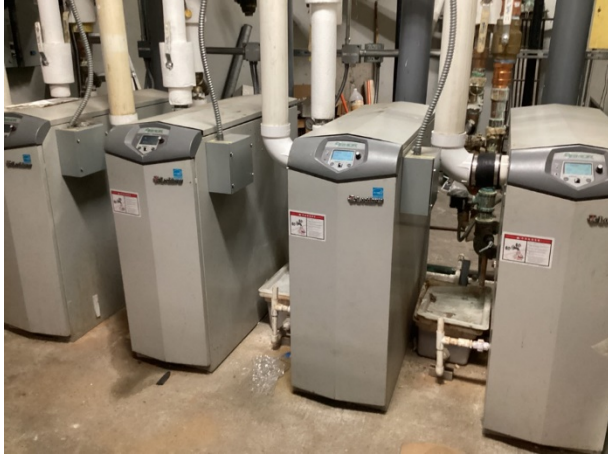
High zone domestic hot water boilers

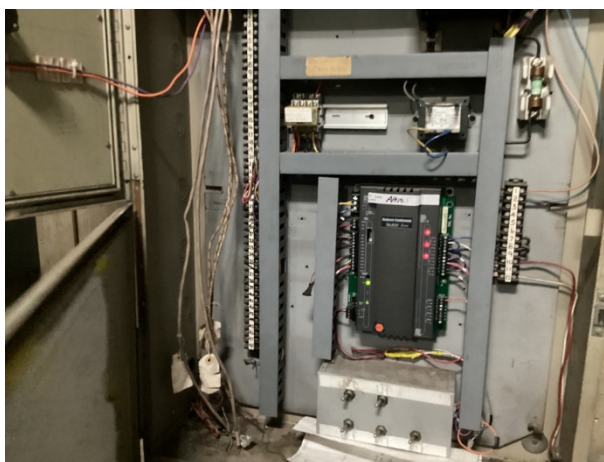
Building automation system panel

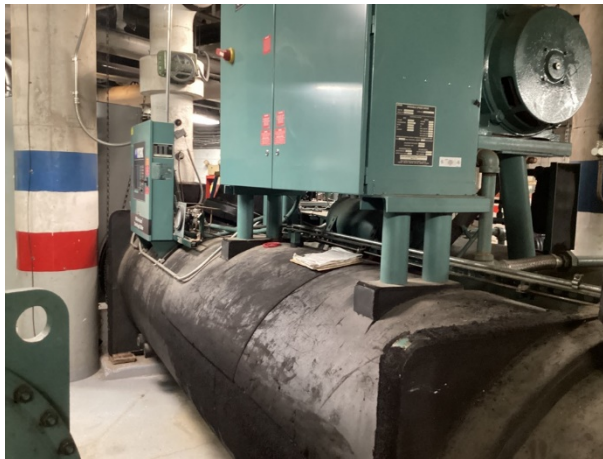
Condition: Reported satisfactory without operational deficiencies

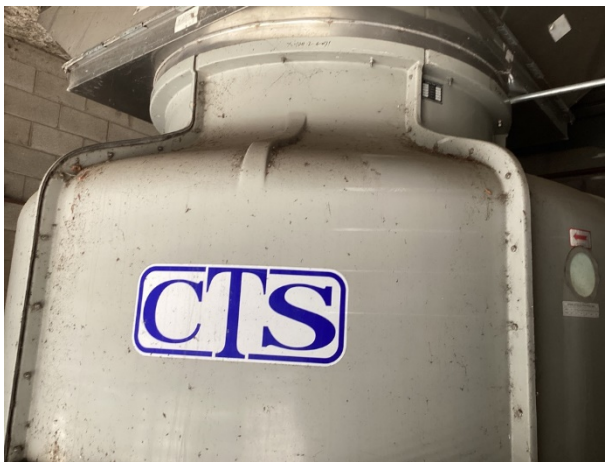
Commercial cooling tower

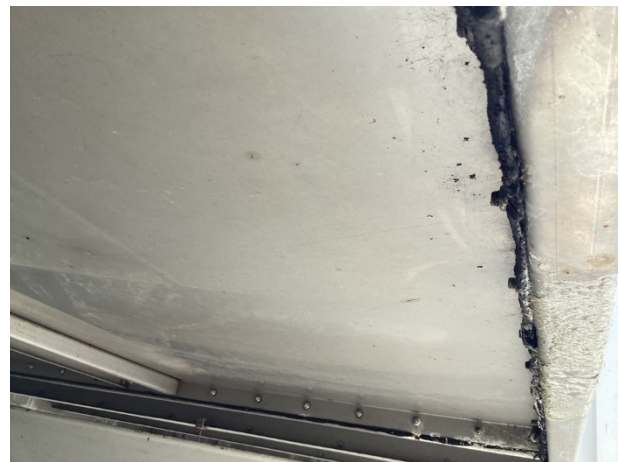
Cooling tower at leakage

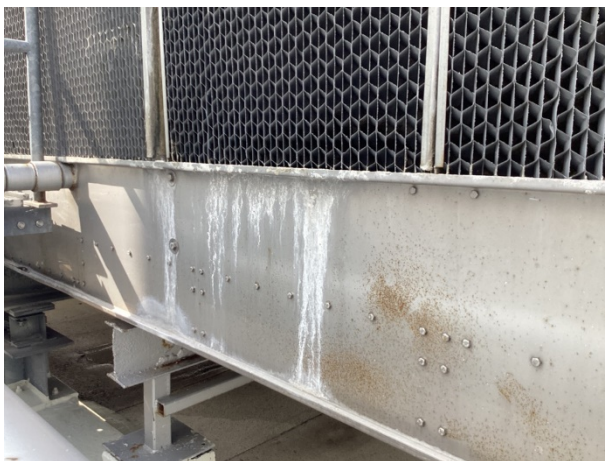
Cooling tower at leakage

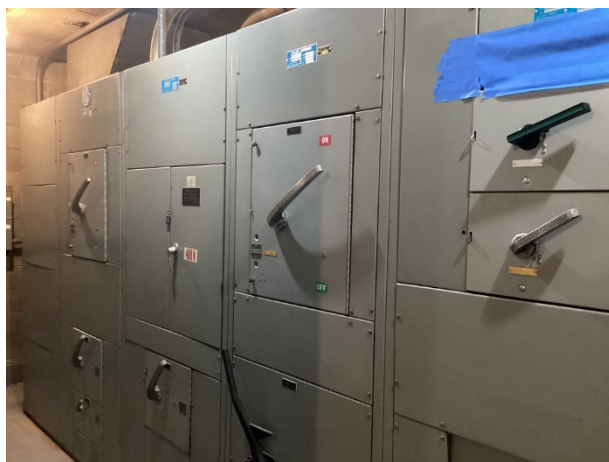
Electrical system main panels

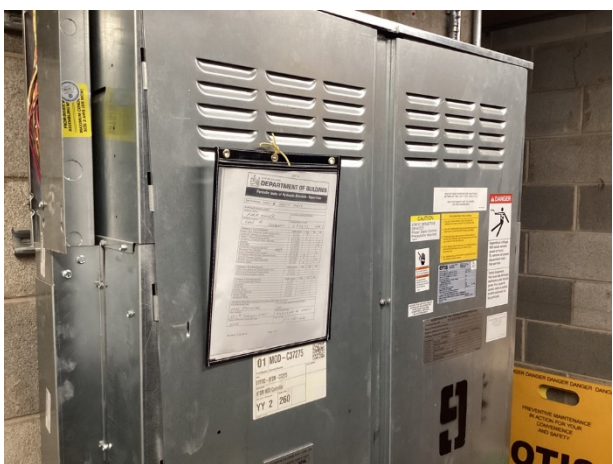
Refuse elevator controls casing

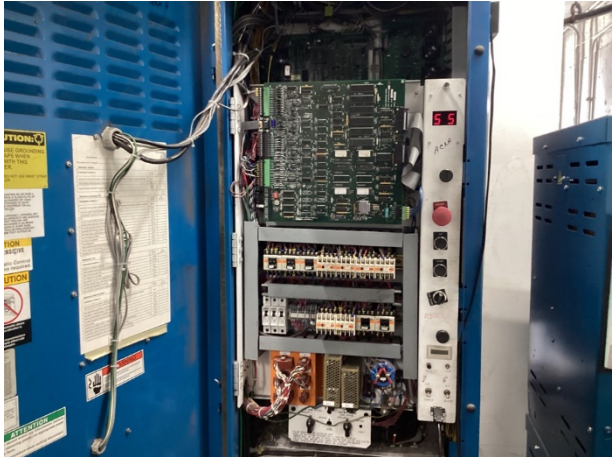
Traction elevator controls

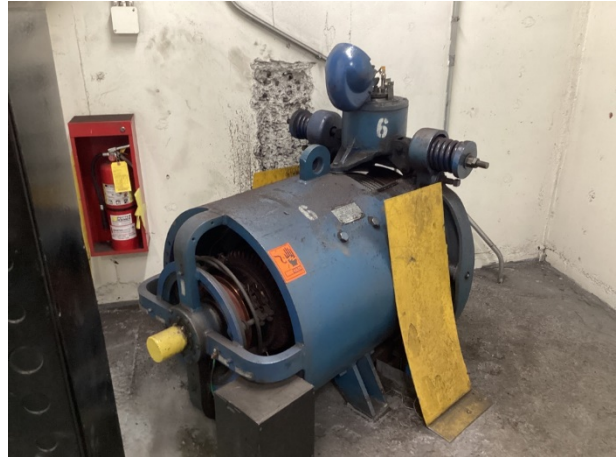
Traction elevator equipment

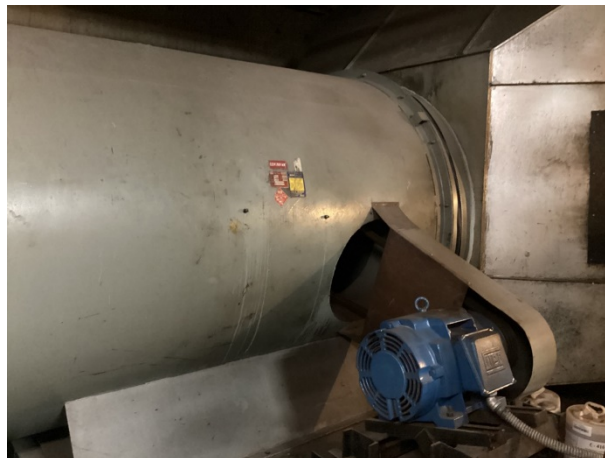
Exhaust fan for kitchens

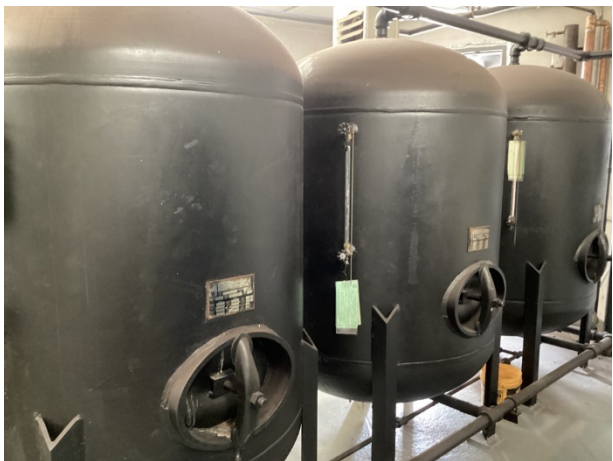
Quantity, History and Condition: The building includes seven large capacity expansion tanks for the high and low level building heating system, and the fin tube loop system. The expansion tanks are original and have capacities of primarily 317- to 564-gallons each.

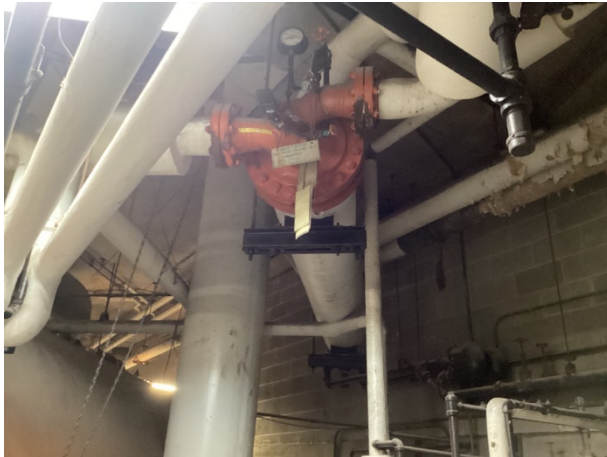
Fin tube heat exchanger

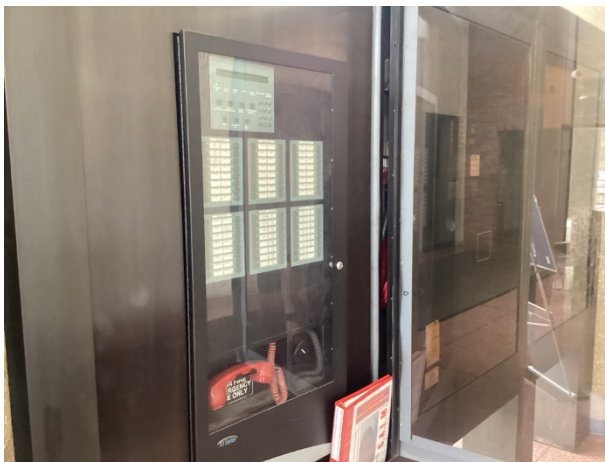
Control panels at lobby

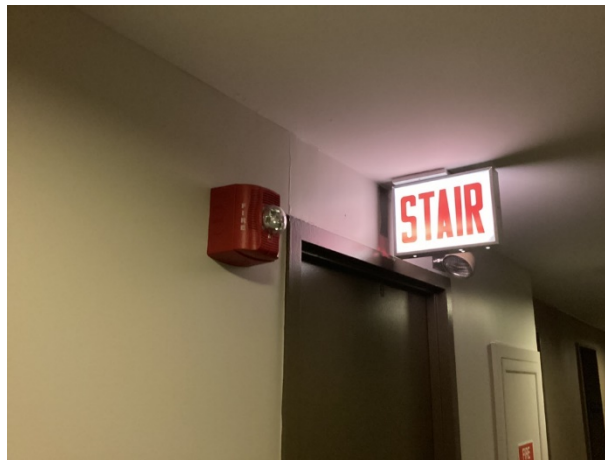
Condition: Reported satisfactory

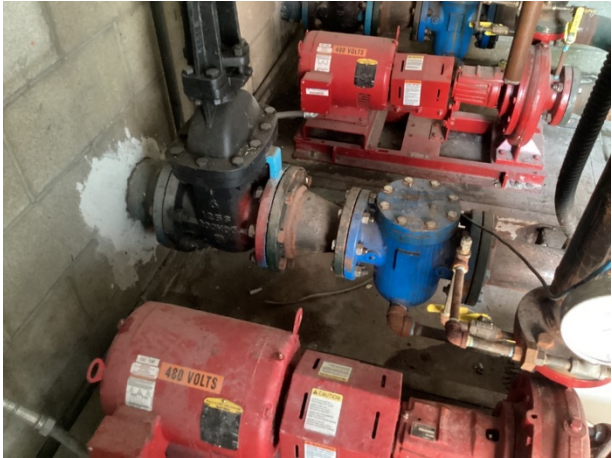
Commercial cooling tower pumps

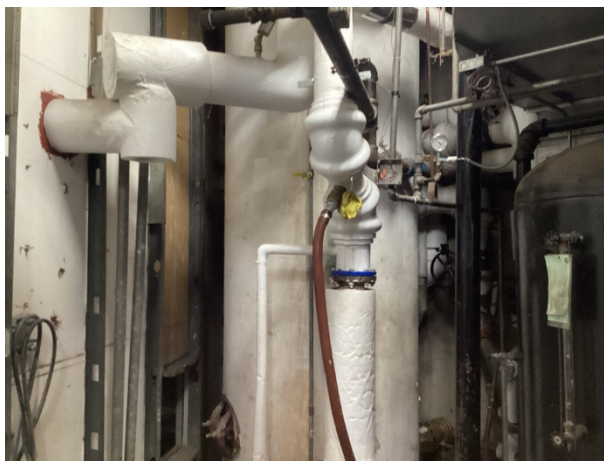
Storage tank for high zone

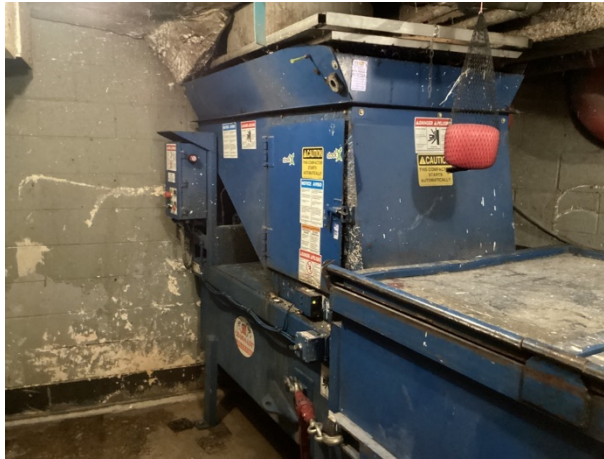
Condition: Reported satisfactory without operational deficiencies

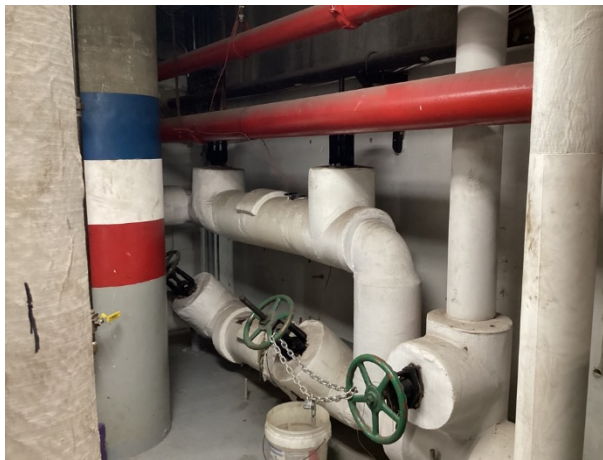
Main water connection large diameter valves

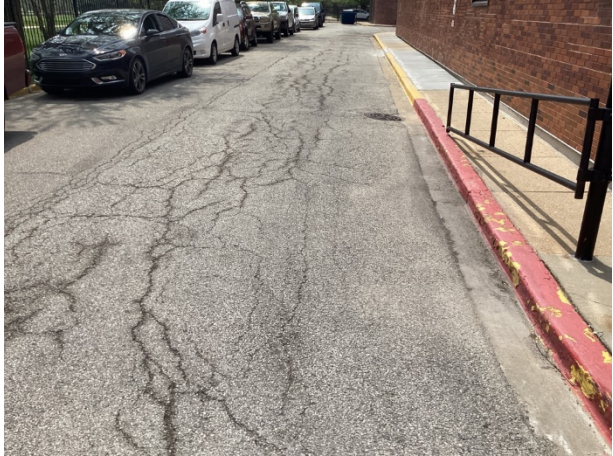
East asphalt pavement deterioration

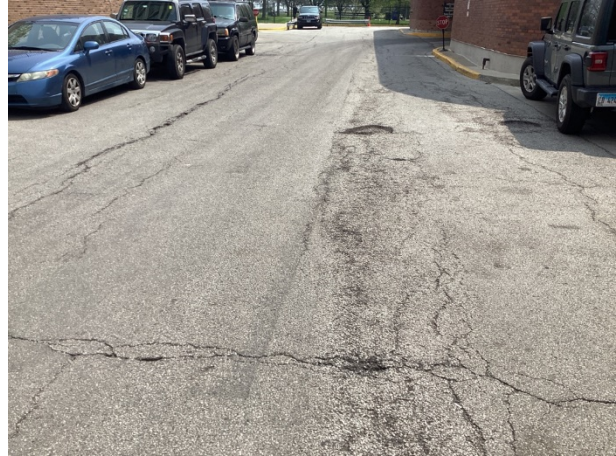
North asphalt pavement deterioration
