RESERVE STUDY

Park Tower Condominium Association

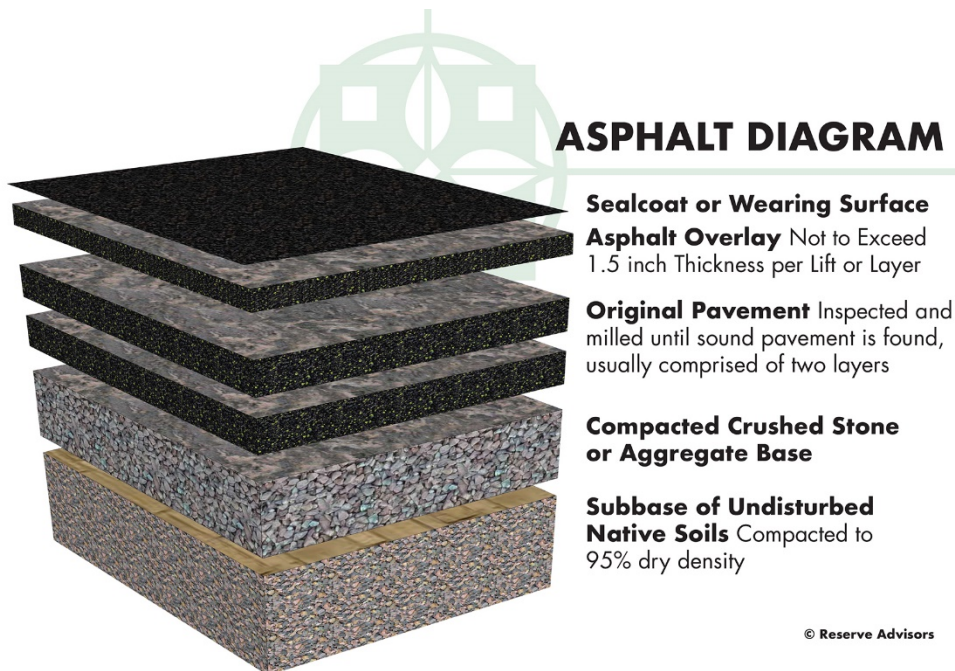
The manner of repaving is either a mill and overlay or total replacement. A mill and overlay is a method of repaving where cracked, worn and failed pavement is mechanically removed or milled until sound pavement is found. A new layer of asphalt is overlaid atop the remaining base course of pavement. Total replacement includes the removal of all

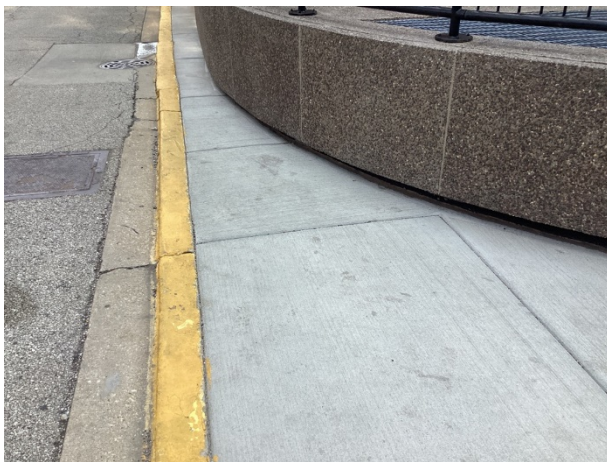
The concrete varies greatly in condition. Areas of cracks are evident. We include periodic allowances for partial replacements of site concrete as the development ages.

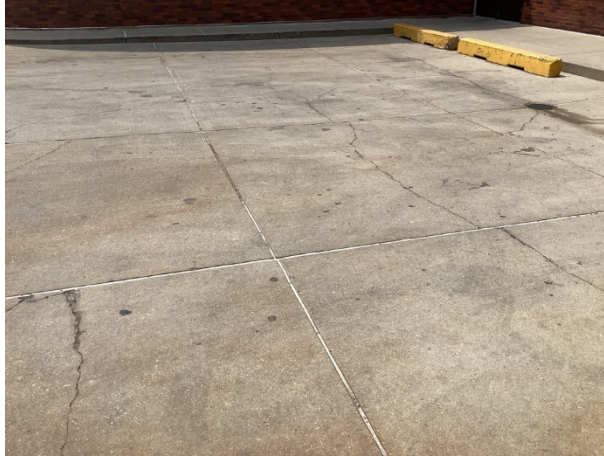
East concrete pavement cracks

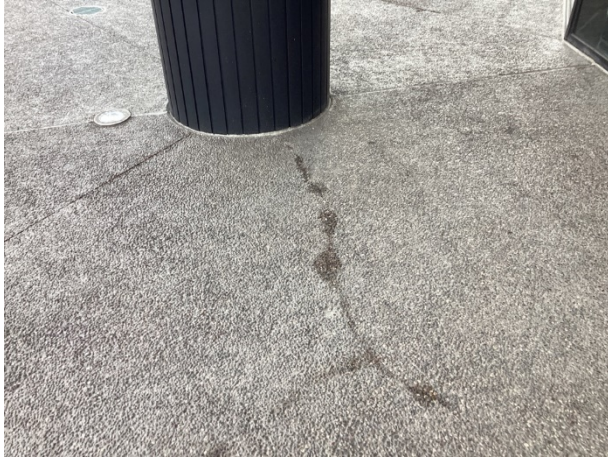
We include a Management provided cost to replace joint sealants and to apply a sealer to the concrete in the near term.

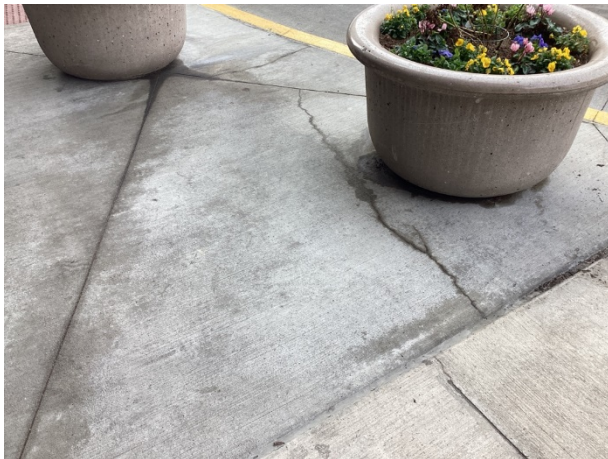
Cracks at vaulted concrete

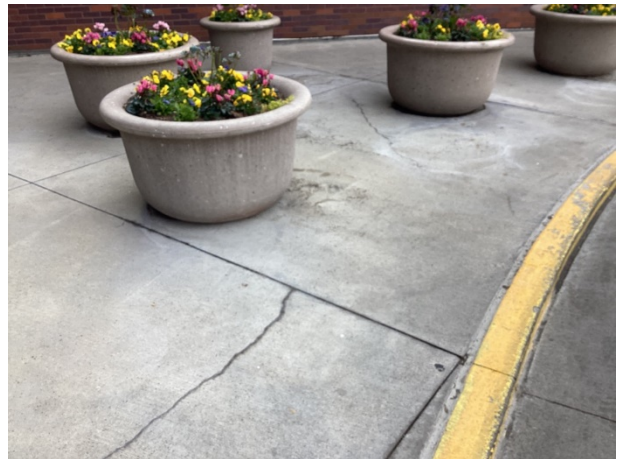
Cracks at vaulted concrete

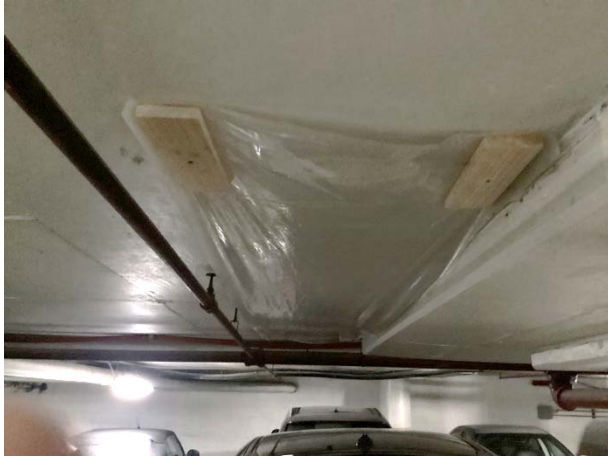
Evidence of past water infiltration beneath plaza

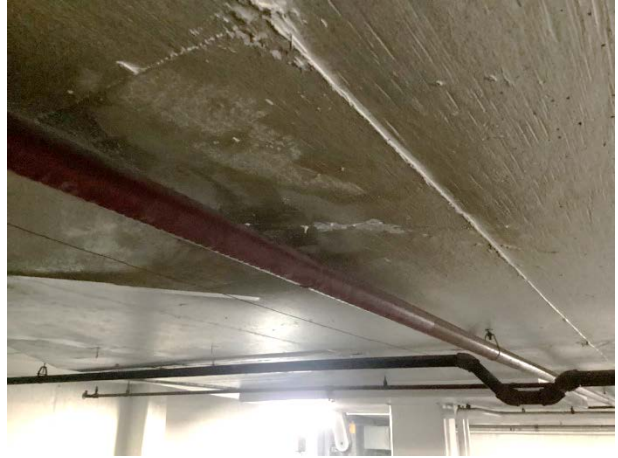
Evidence of past water infiltration beneath vaulted plaza

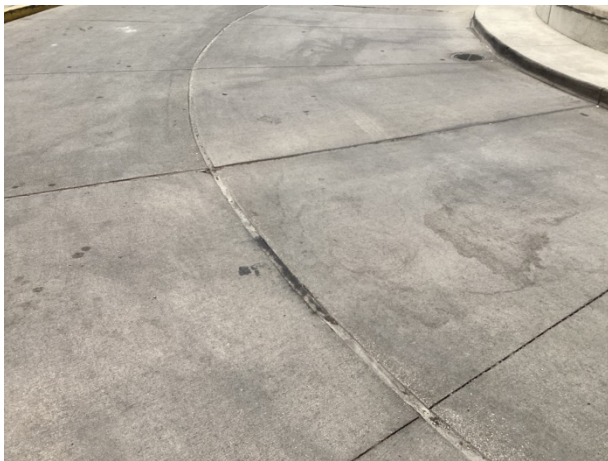
Joint sealant at pavement

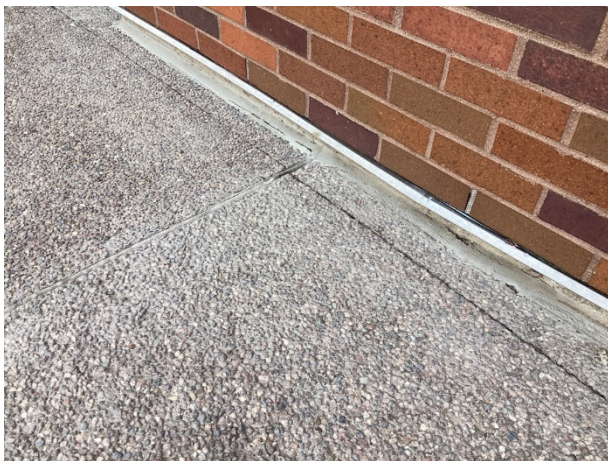
Sealant deterioration at plaza

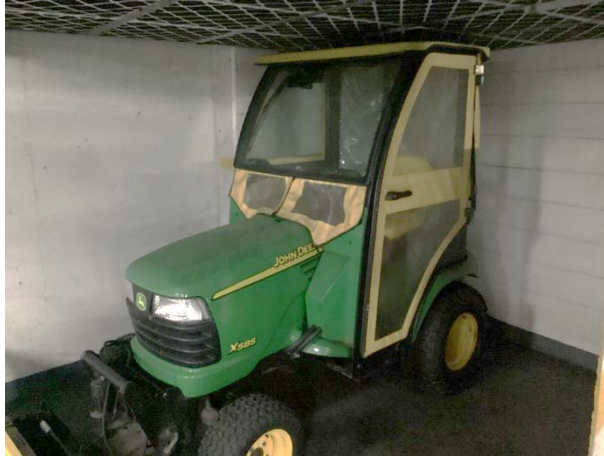
History: We include a Management provided cost to replace the tractor in the near term.

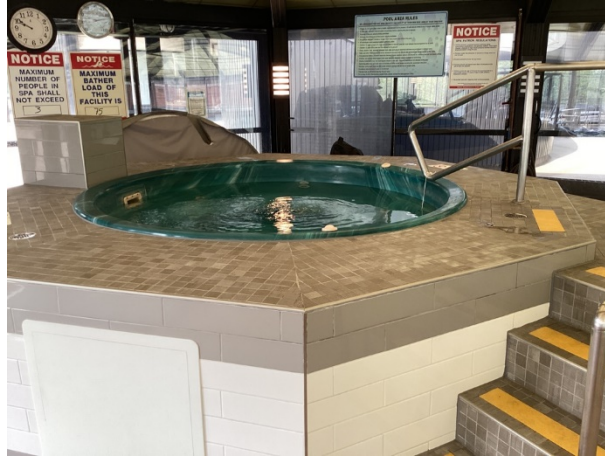
Condition: The hot tub insert is in reported satisfactory condition.

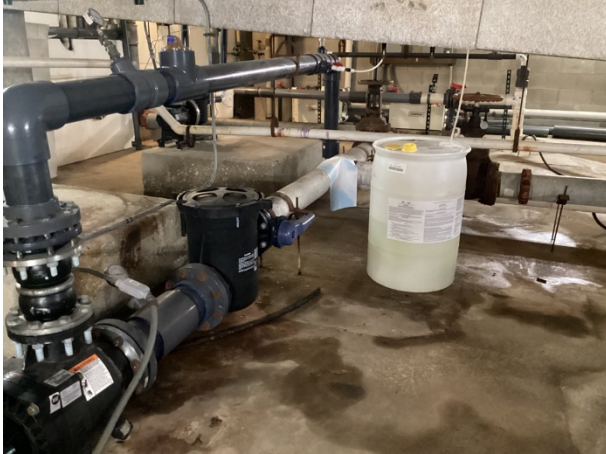
Mechanical equipment for pools

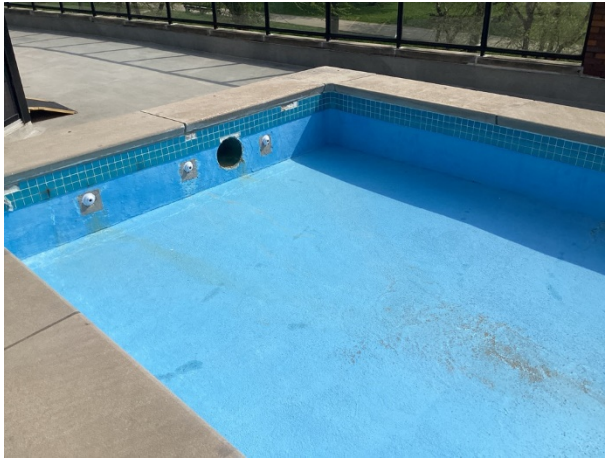
Tile damage at outdoor pool

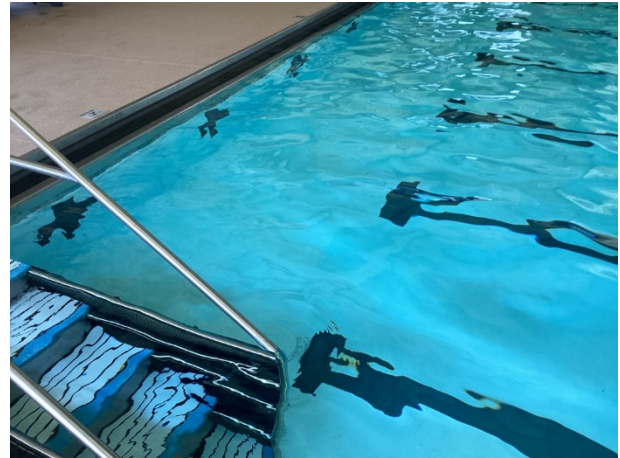
Indoor pool at liner

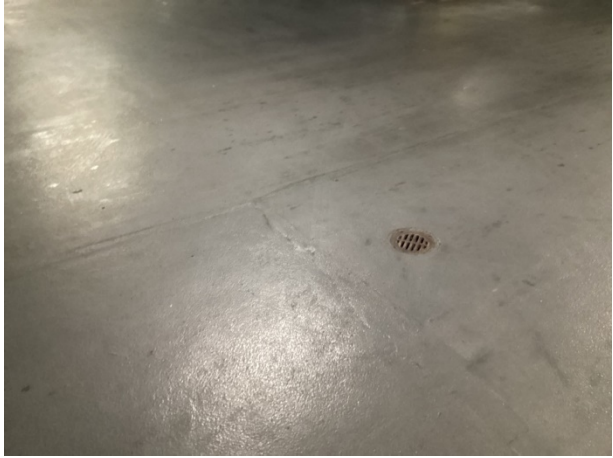
The ceiling beneath the elevated floor exhibits a significant amount of concrete repairs.

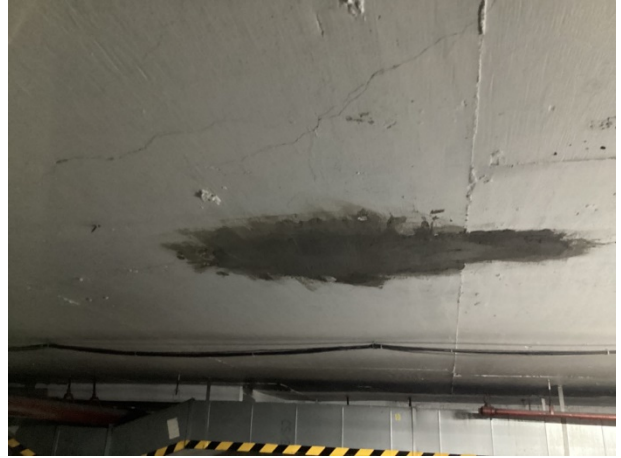
Concrete repairs beneath 1P

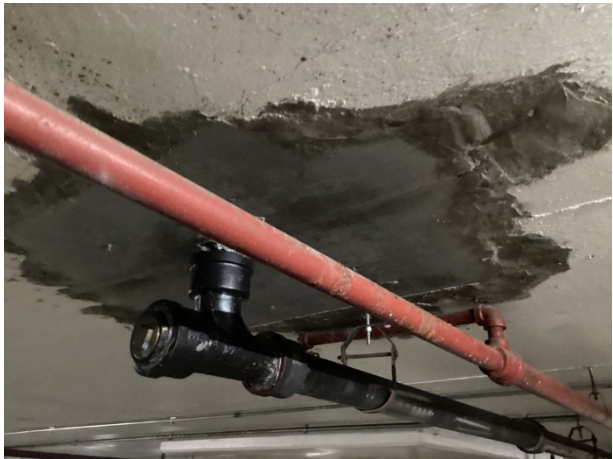
Concrete repairs beneath 1P

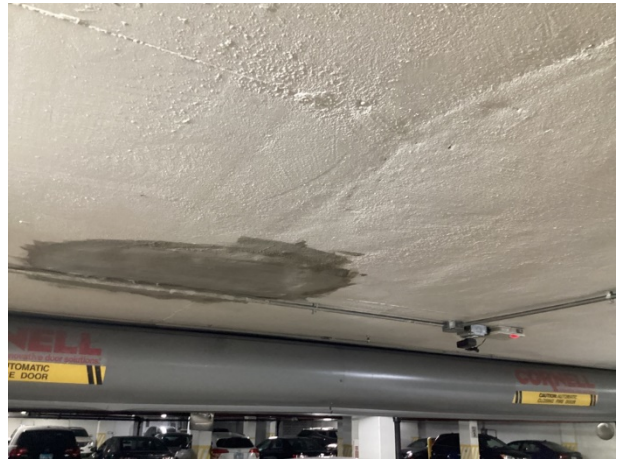
Concrete repairs beneath 1P

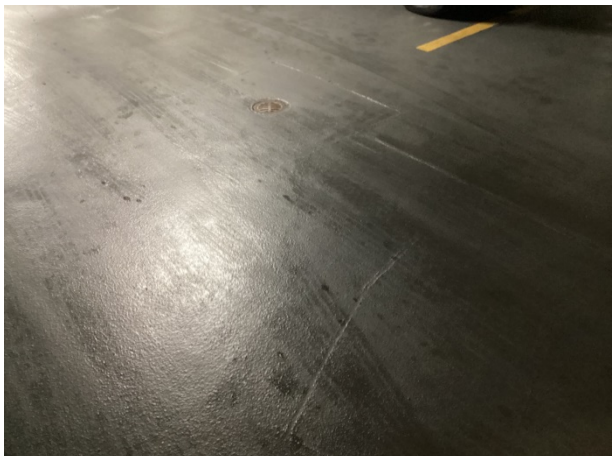
Concrete repairs beneath traffic coating

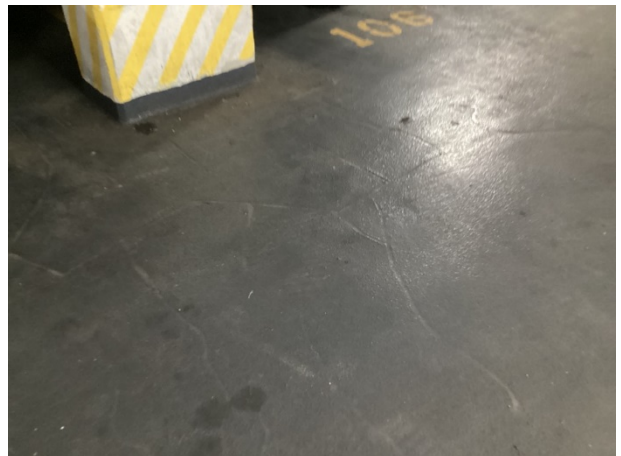
Concrete repairs beneath traffic coating

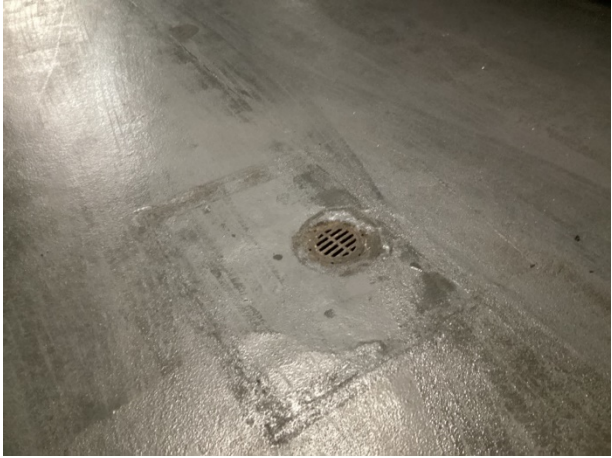
Traffic coating at drain

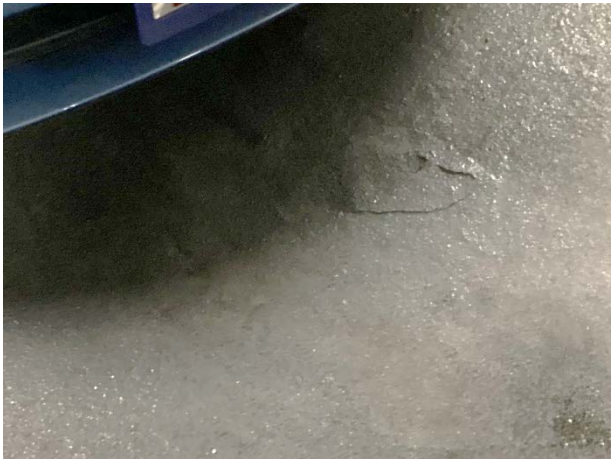
Traffic coating damage at valet

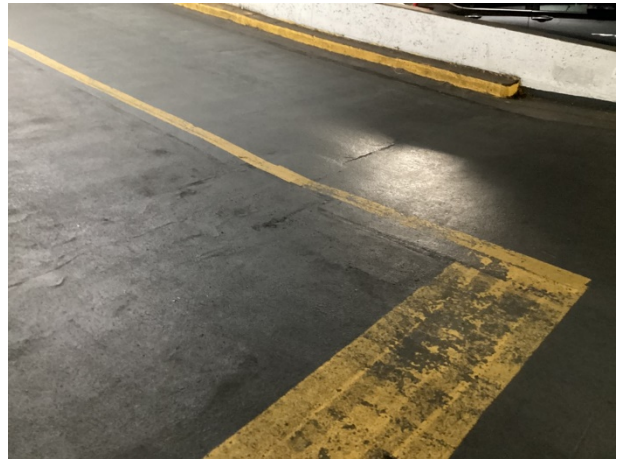
Traffic coating wear at ramp

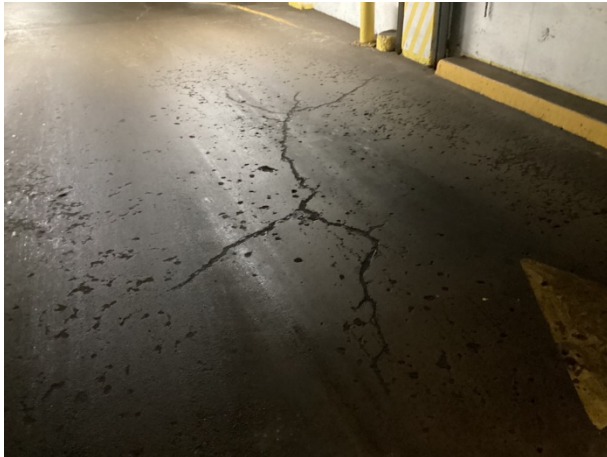
Concrete cracks and spall

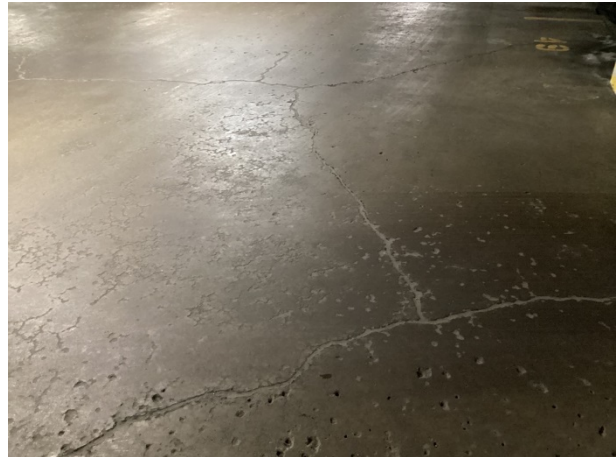
Concrete cracks and spall

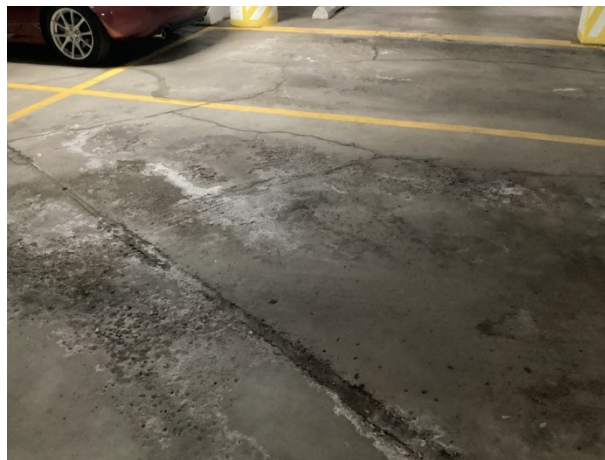
Concrete cracks and spall

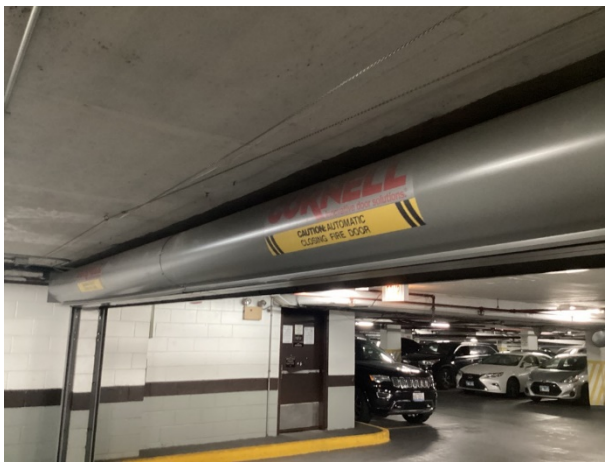
Condition: The fire doors are in reported satisfactory condition. We include a Management provided cost to replace the vehicular doors with rolling doors in the near term.

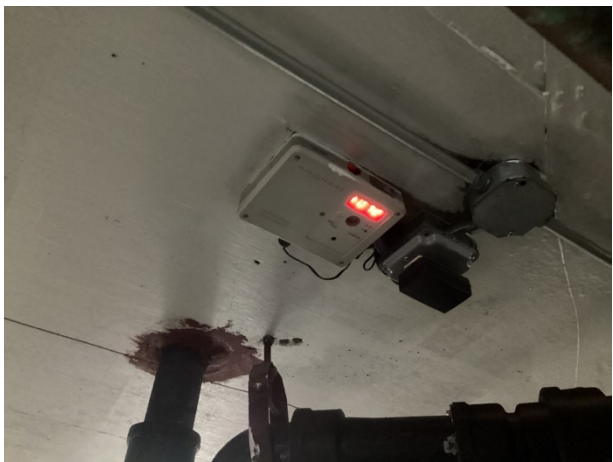
Carbon monoxide detector

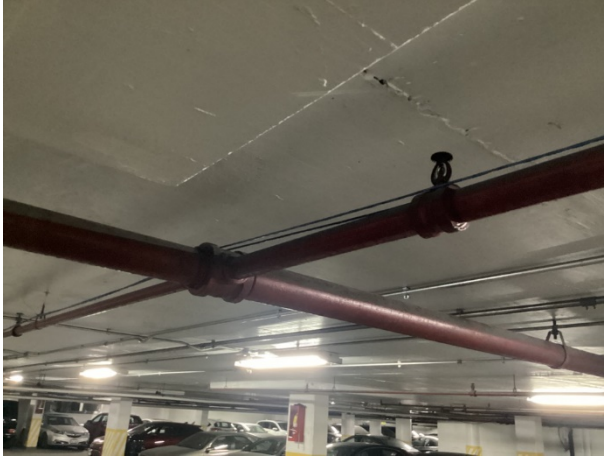
Fire suppression system at main and branch pipes

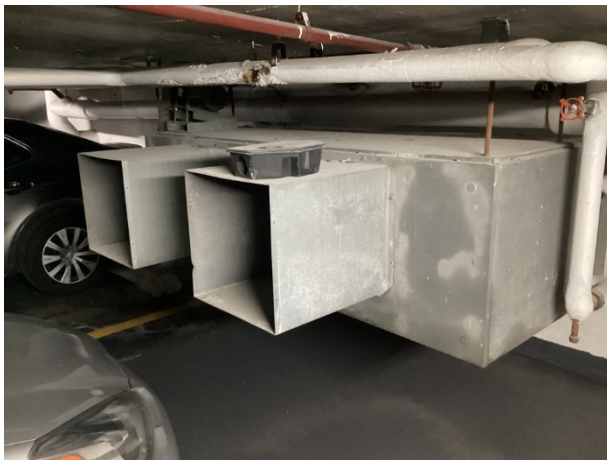
Condition: Reported satisfactory
